# Manhole Inspection Summary

Manhole # S150\_\_009MH

Insp Date: **3/27/08 11:00 AM**

**Location** Address: **2709 LEHMAN ST**

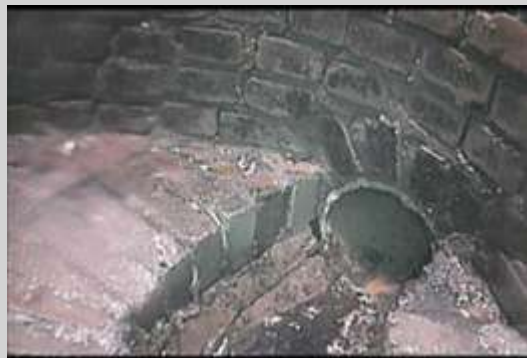
8 O'Clock Inflow

8 in. Circular Gravity Sewer  
Pipe In @ 8 O'Clock

Pipe Height: **8.4** (in.) Rod and Bar (Angled)

Pipe Material: **Clay** ☐ Pipe Lined

Infiltration: **None** Pipe Seal Cond: **Sound**
